Sumatra Earthquake 26 Dec 2004

Teddy Boen

1. Aceh Tsunami Dec 26, 2004

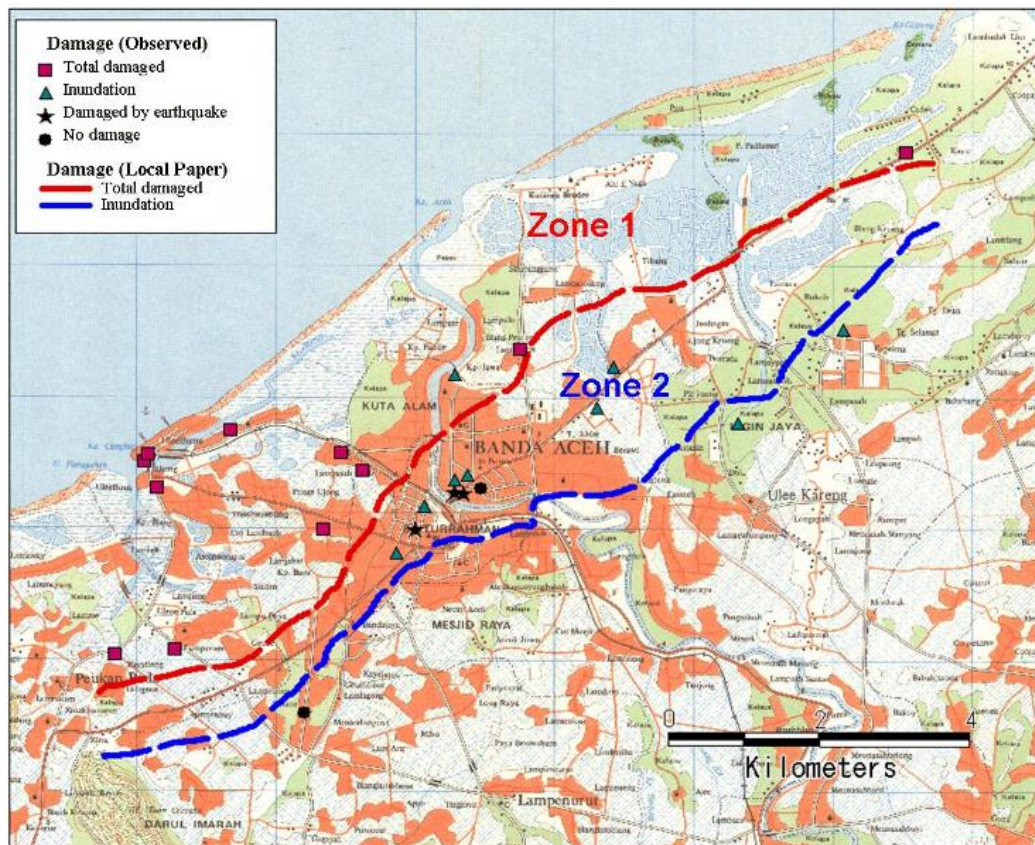
Damaged & Inundation Zones in Banda Aceh

In general there are two zones affected by the tsunami, zone 1 is the coastal areas were destructed by the tsunami forces such as battering, scouring, impact and buoyancy. In Banda Aceh this zone goes up to 3 km inland. Zone 2 was only inundated, where the tsunami force is already reduced and only caused flooding, dumping mud and debris. This area is approximately 0.5 to 1.5 km further inland.

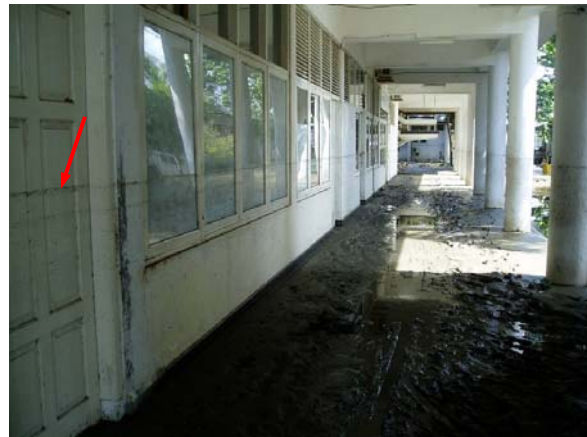
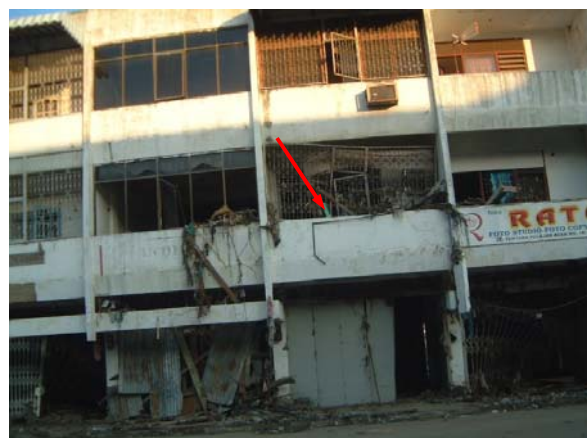
Inundation Height in Banda Aceh

- Meulaboh (Western Coast) about 4 m
- Lhok Nga (West of Banda Aceh) about 15 m (run-up height against hillside)
- Banda Aceh about 8 m in coastal areas (zone 1) and 2-3 m in zone 2
- Krueng Raya (North coast) about 6 m (watermark on coastal side wall of the Mosque)

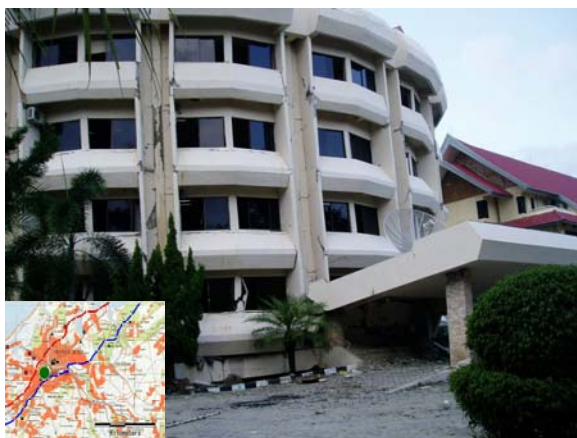
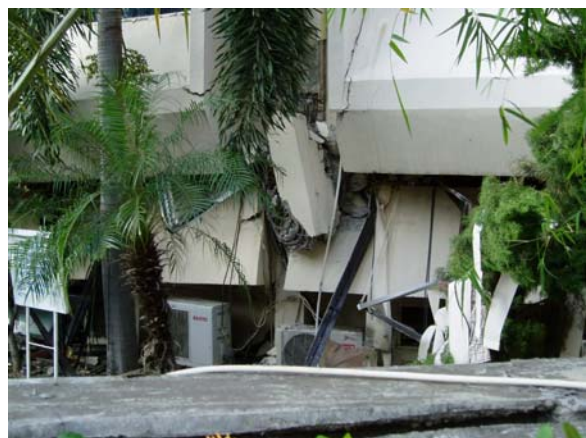
Kuala Tripa Hotel

Right after the M 8.9 occurred, some high-rise buildings were damaged and a couple collapsed. The most obvious damage occurred to Kuala Tripa hotel, a 5 story RC building. It suffered a “first soft story” collapse. The second and third floor was severely damaged because of the impact but the building as a whole did not collapse. The collapse was caused by poor detailing and most probably it was analyzed as 2-D structures, therefore overlooking the first soft story effect. Another visible collapse was a three story supermarket, the Pante Pirak. The collapse was due to poor quality of construction. Another building that partially collapsed was the office of the department of finance. One of the wings suffered a pancake type of collapse. From the damaged columns it can be seen that the detailing was poor. This building suffered partial damage when shaken by a moderate earthquake in 1983. There were few other buildings such as two stories shop house buildings that were damaged by the earthquake shaking, however, most of those buildings were poorly designed as well as poorly constructed. In general, it can be said that very few buildings collapsed or were damaged by the Dec 26 2004 earthquake shaking because the epicenter was some 240 km away from Banda Aceh. Even the subsequent aftershocks with an epicentral distance of approximately 100 km, did not cause any further damage to those buildings as well as other buildings.

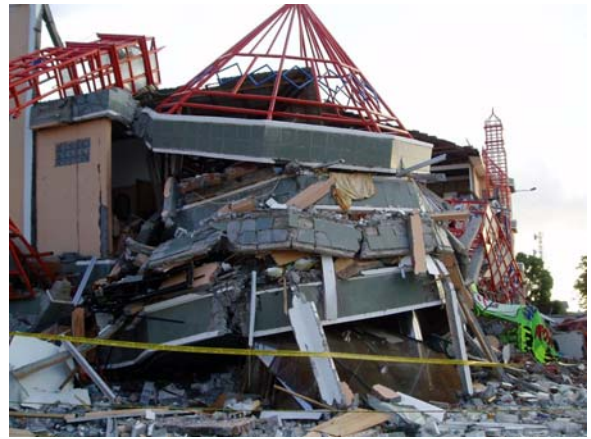
Pante Pirak Supermarket

The causes of typical damage of reinforced concrete engineered buildings during the Sumatra earthquake in Banda Aceh were mostly due to vertical irregularities in certain RC buildings creating abrupt changes in stiffness and strength that may concentrate forces in an undesirable way. Also poor quality of concrete and detailing contributed to the collapse of those engineered buildings.

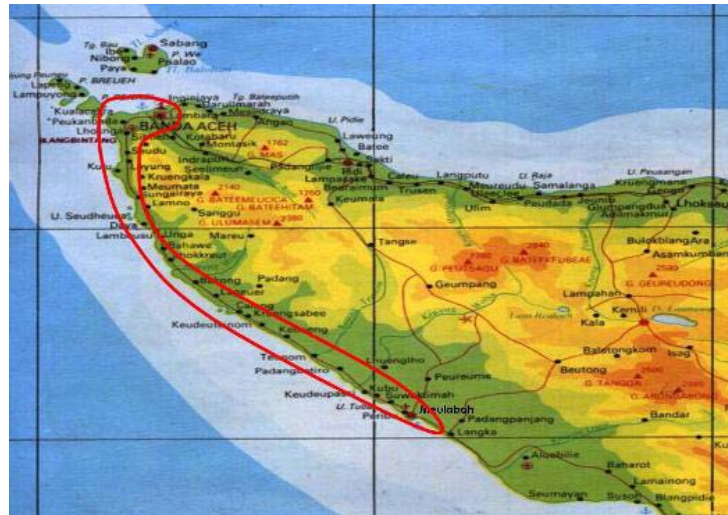
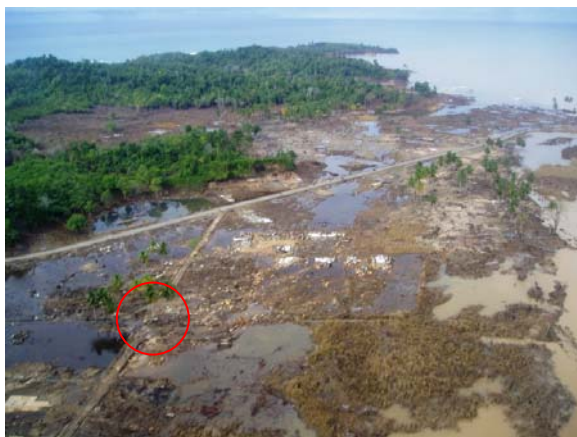
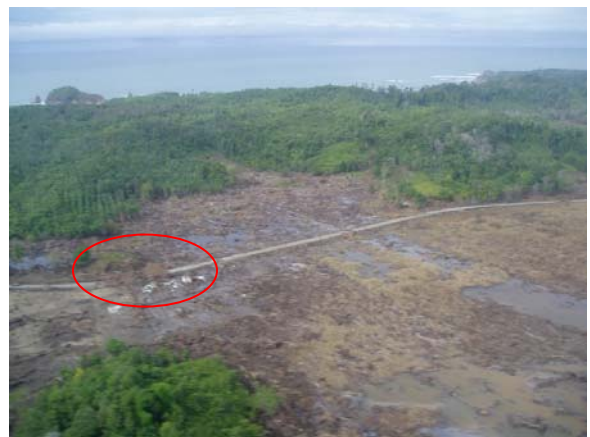
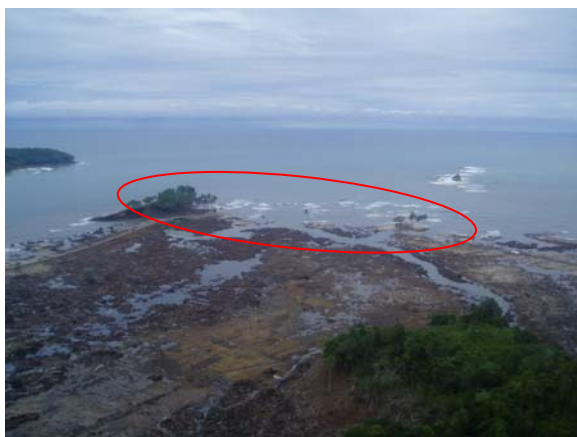
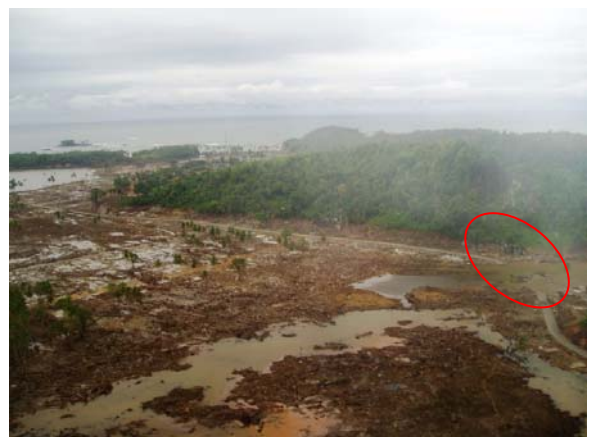
Some of the Damage of Roads and Bridges from Banda Aceh to Meulaboh

Some roads in Banda Aceh were scoured by tsunami but the majority was still in tact. Most of the main roads in zone 1 were covered by huge amount of tsunami debris. Several parts of the road from Banda Aceh to Meulaboh were washed away by tsunami.

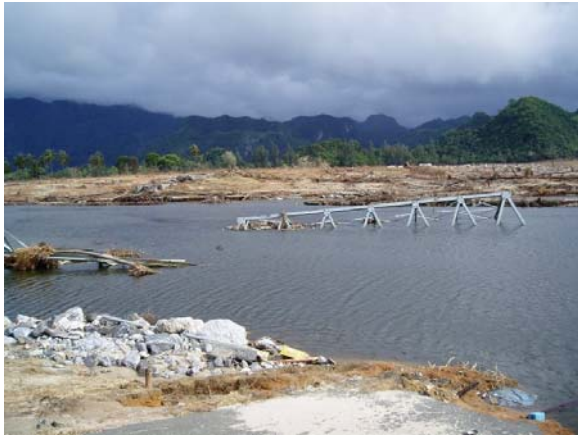
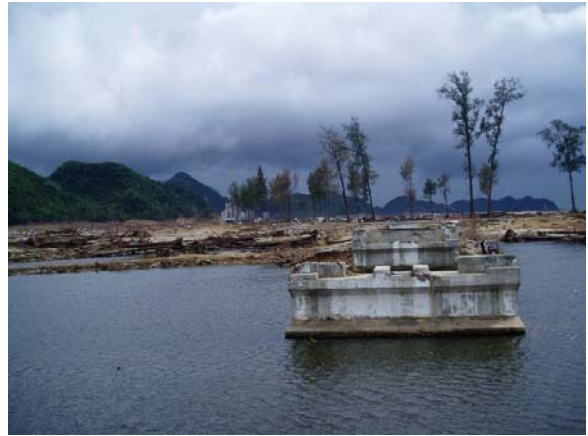
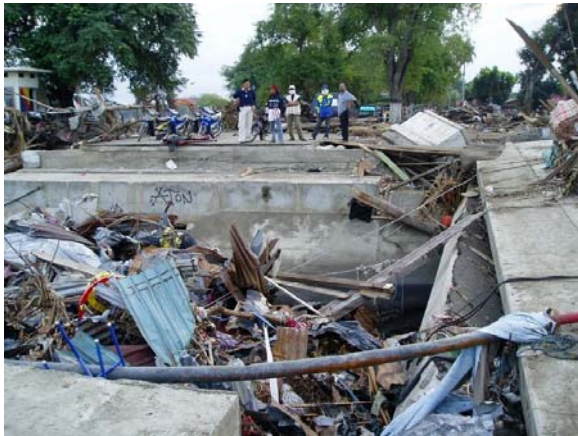
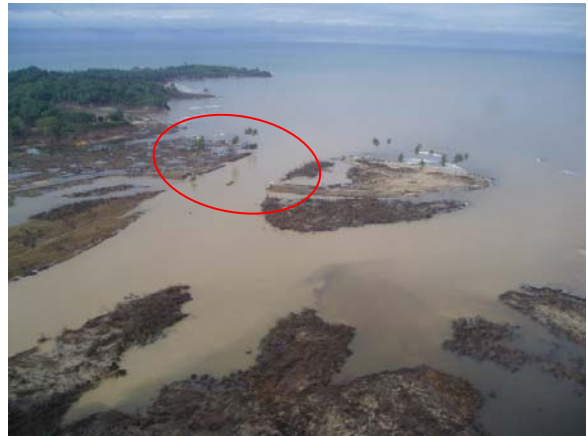
In Banda Aceh, several bridges were destroyed, the one at Jl Iskandar Muda and the one leading to Lhok Nga. The Lhok Nga Bridge has a main span of 20 m and secondary span of 10 m made of galvanized steel frames. Both were dumped into the river. Along the road from Banda Aceh to Meulaboh (distance approx 270 km), several bridges were washed away by tsunami.

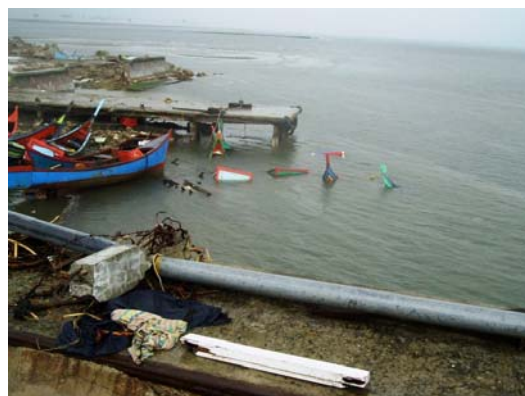
Fishermen Jetty in Ulhue Lhe

Generally, jetties and wharf of ports in Banda Aceh and in Kreung Raya as well as the jetty of the cement factory Lhok Nga were slightly damaged but could still function. Part of the platform of the jetty in Meulaboh was washed away by tsunami, but the supports were still in tact. The main building of the Ulhue Lhe harbor in Banda Aceh was damaged and only the frame remained.

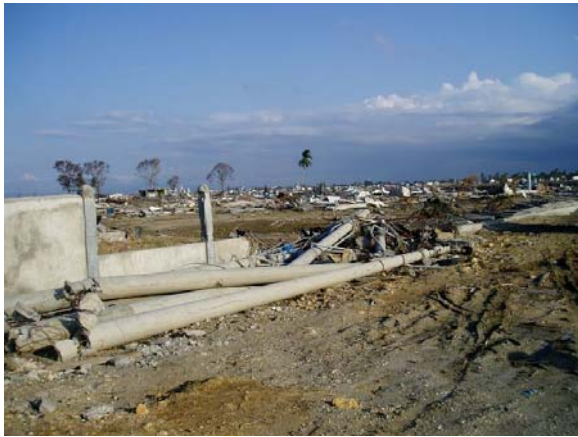
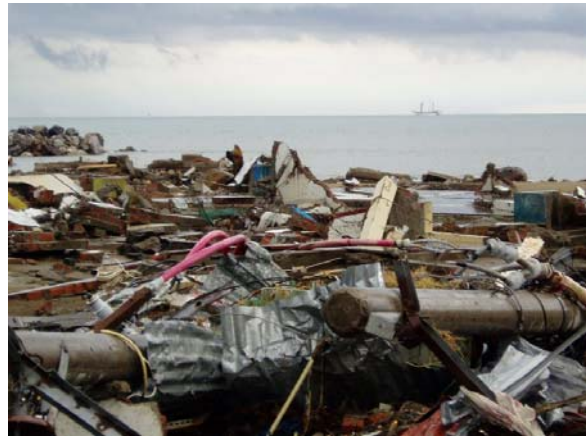
Main Power generating plant in Banda Aceh was not affected by the shaking or tsunami. However, many distribution poles and wires in devastated areas collapsed.

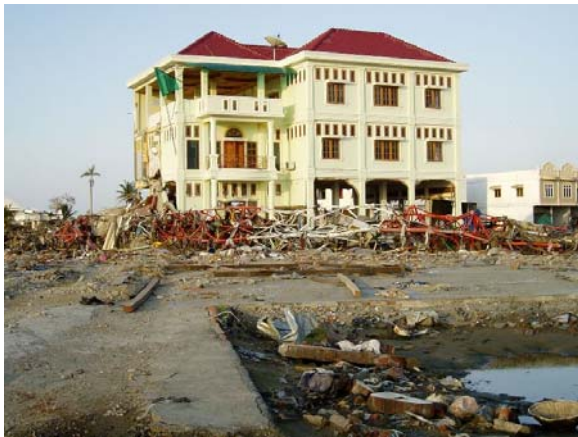
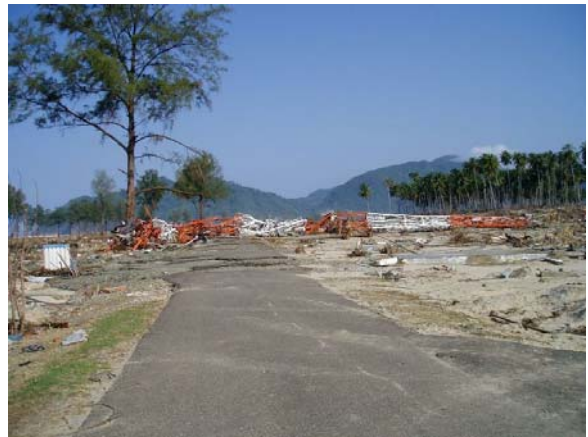
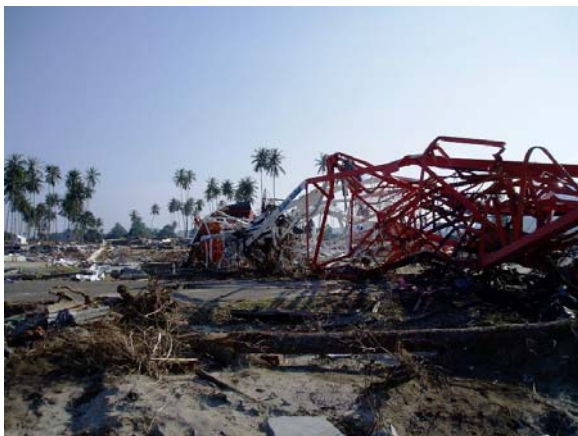
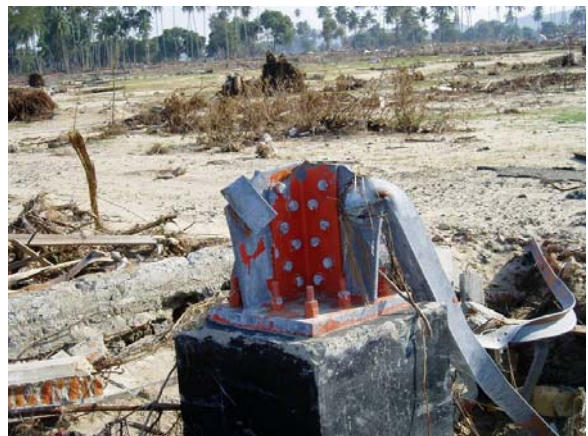
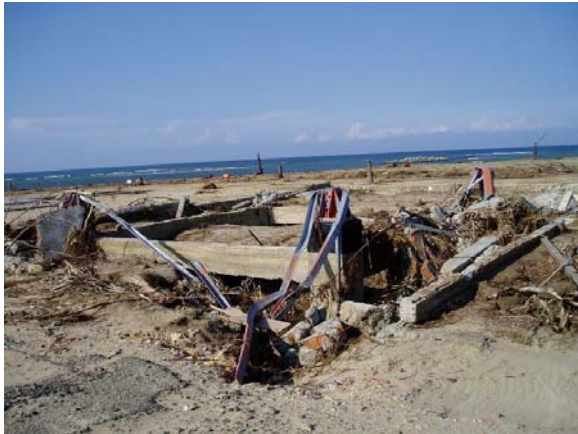
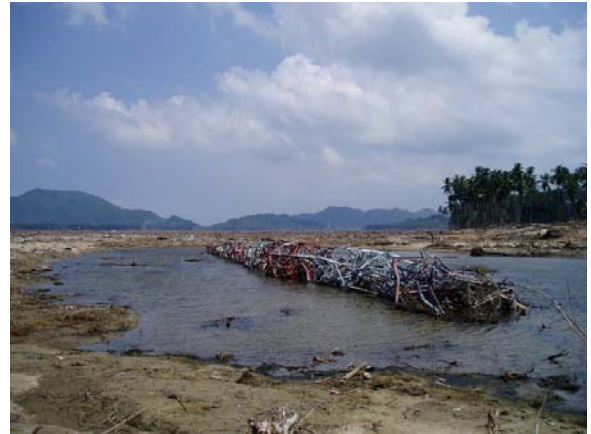
Some mobile phone antennas towers were dismantled by the tsunami and dragged up to 2 km from its foundations. Many telephone junction boxes were practically destroyed.

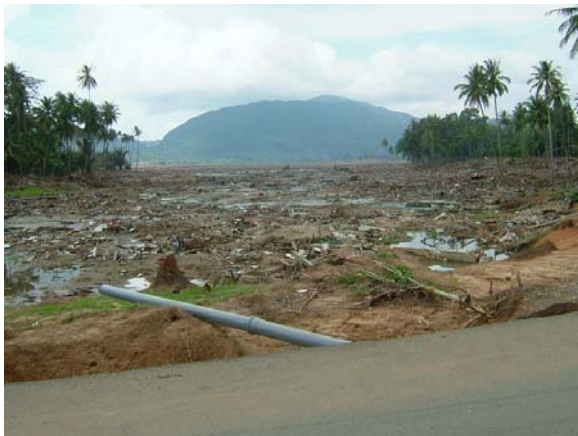
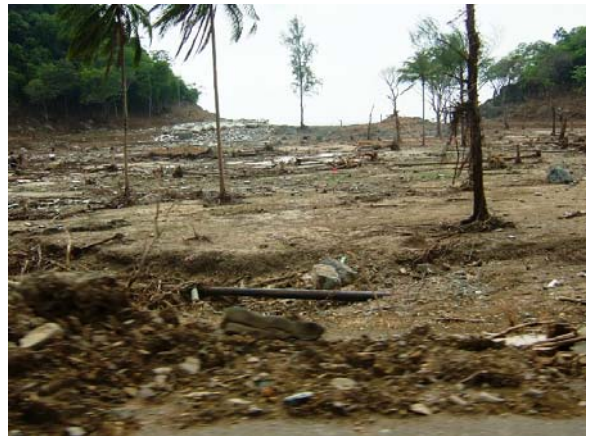
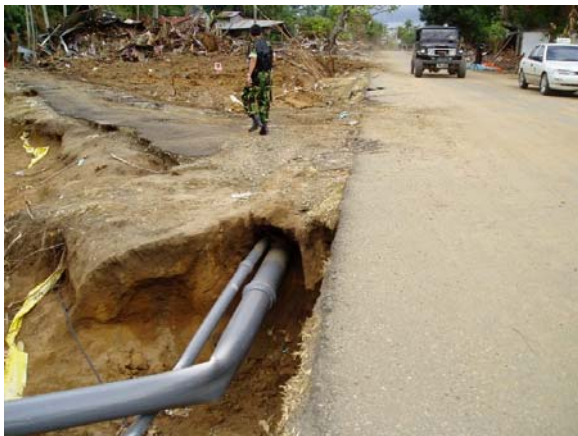
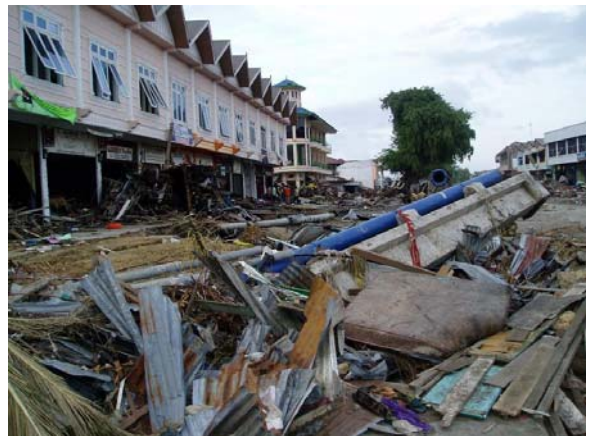
Water Treatment plant in Banda Aceh was not affected by neither the shaking nor the tsunami, however, the piping systems were destroyed by scouring of the tsunami.

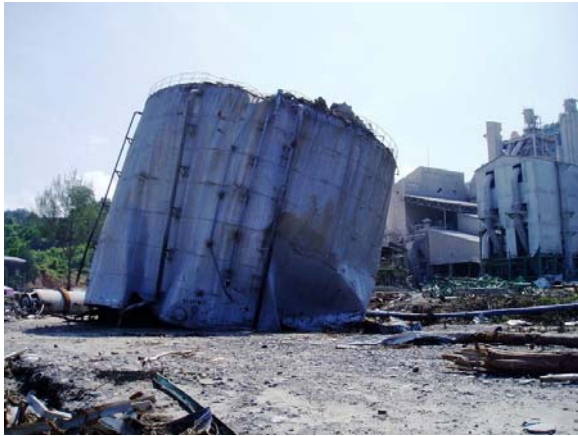
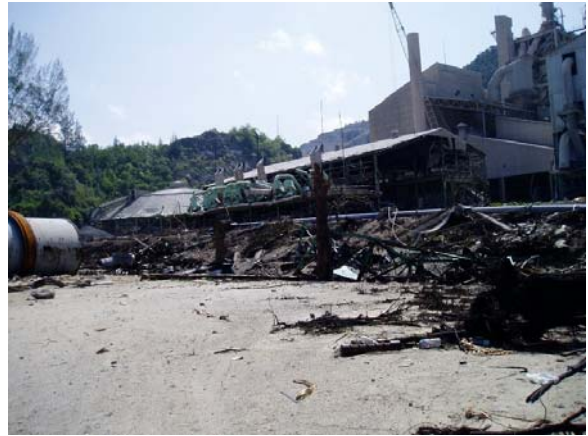
Cement Factory, Lhok Nga

- A cement factory located at beach side in Lhok Nga district was severely damaged.
- Oil depot in Kreung Raya (East of Banda Aceh) was damaged and several storage tanks were dragged up to 1 km. The tanks were submerged by about one-third of its height.
