Effects of landslides on Machu Picchu Cultural Heritage

Paolo Canuti, Riccardo Fanti (University of Firenze, Italy), Claudio Margottini, Daniele Spizzichino (APAT, Italian Environment Protection and Technical Services Agency, Rome, Italy)

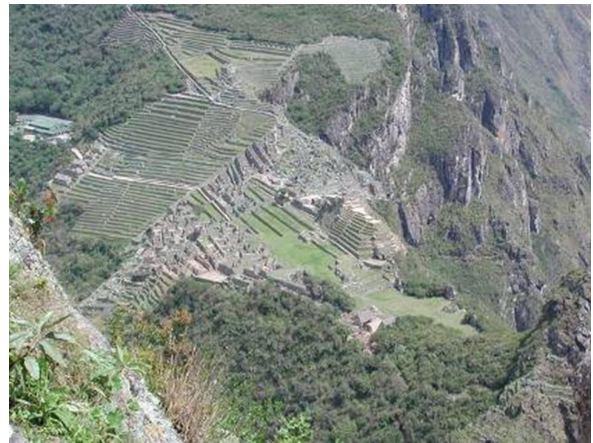
Fig. 1 General view of the archaeological site of Machu Picchu citadel (photo by D. Spizzichino)

The archaeological site is indeed located on the crest of two mountains, 2430 m.a.s.l., with the Urubamba river at its foot in a very inaccessible zone of Andean forest (fig.1). All the theories provided so far are based on studies and archaeological discoveries but there are no historical sources which provide information as to what happened in the "Lost City".

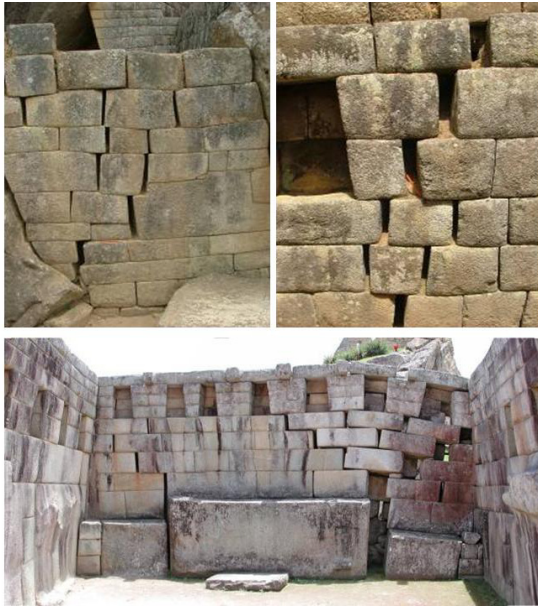
Fig. 3 Examples of cracks collected in the archaeological structures and buildings (photos by D. Spizzichino)

For each typology of element at risk a value of damage has been defined, after the stage of inventory and filling of a field survey catalogue (fig. 3). The field catalogue for the survey of the static-structural conditions of CH exposed at landslide risk has been derived from similar experiences carried out for the assessment of seismic vulnerability/degree of damage. In particular, the following parameters have been adopted:
