Detection of exterior damage of buildings from high-resolution SAR images

September 19, 2014

Fumio Yamazaki^{a)}, Yoji Iwasaki^{b)}, Wen Liu^{c)},
Takashi Nonaka^{d)} and Tadashi Sasagawa^{d)}

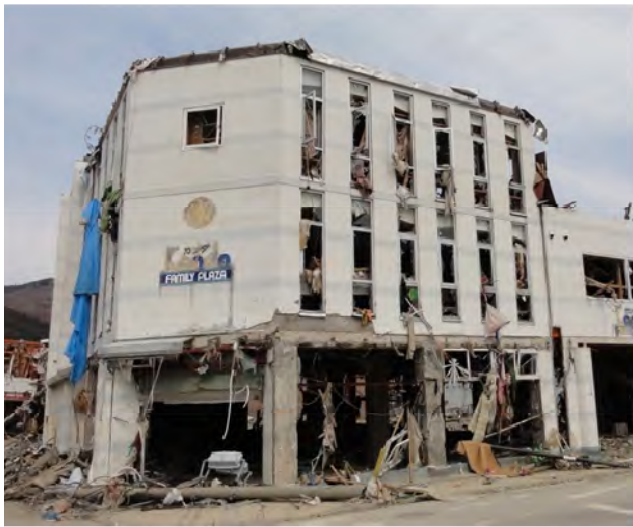
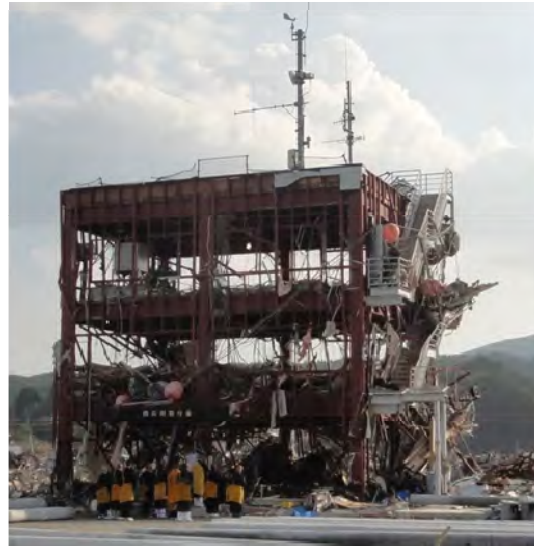
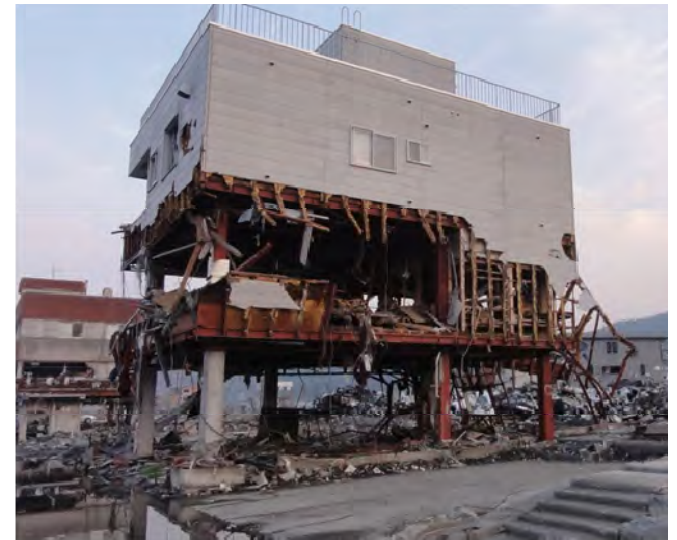
Typical tsunami damage to reinforced concrete and steel-frame buildings observed in our field survey after the 2011 Tohoku, Japan, earthquake

The damage was concentrated to exterior walls and lower stories of buildings.

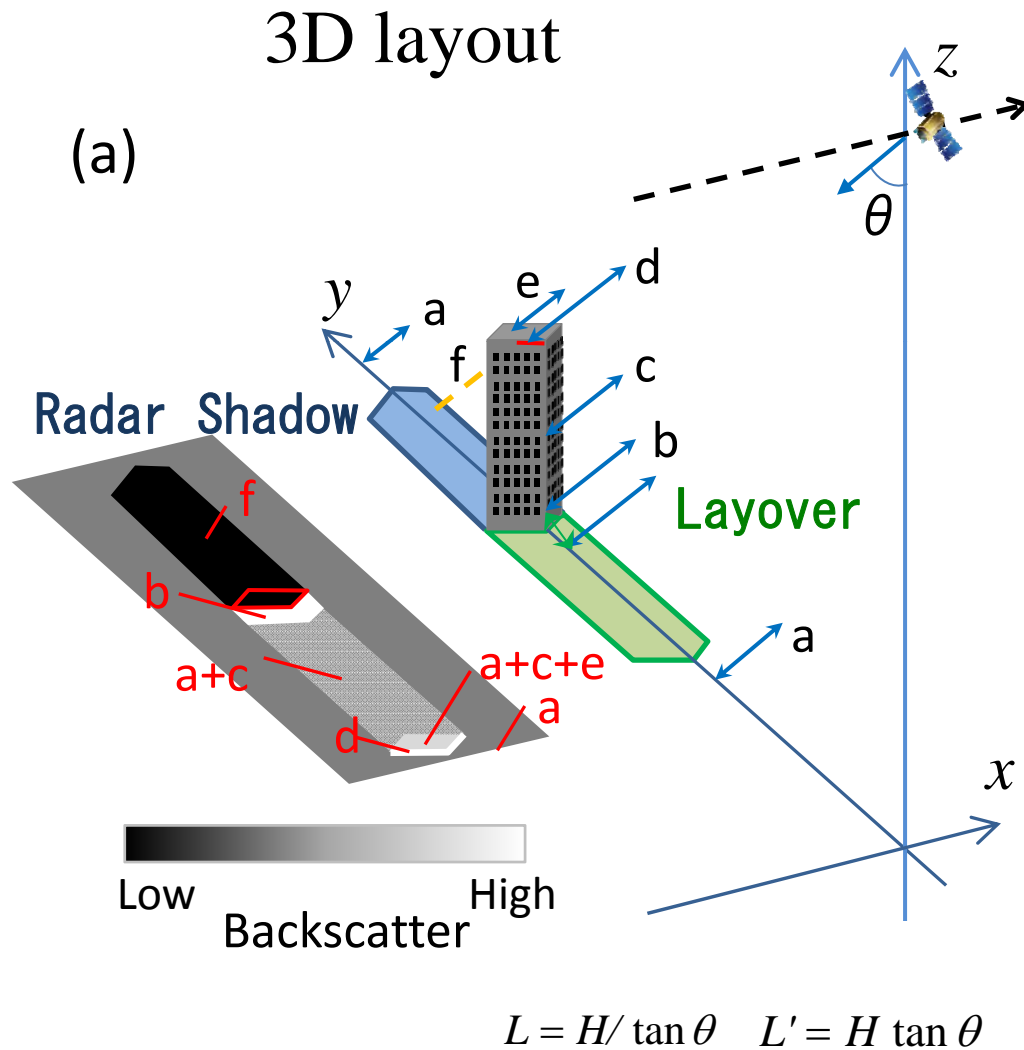
Scheme of SAR observation for a tall flat-roof building

Radar Shadow

Layover

$$L' = H \tan \theta$$

$$L = H / \tan \theta$$

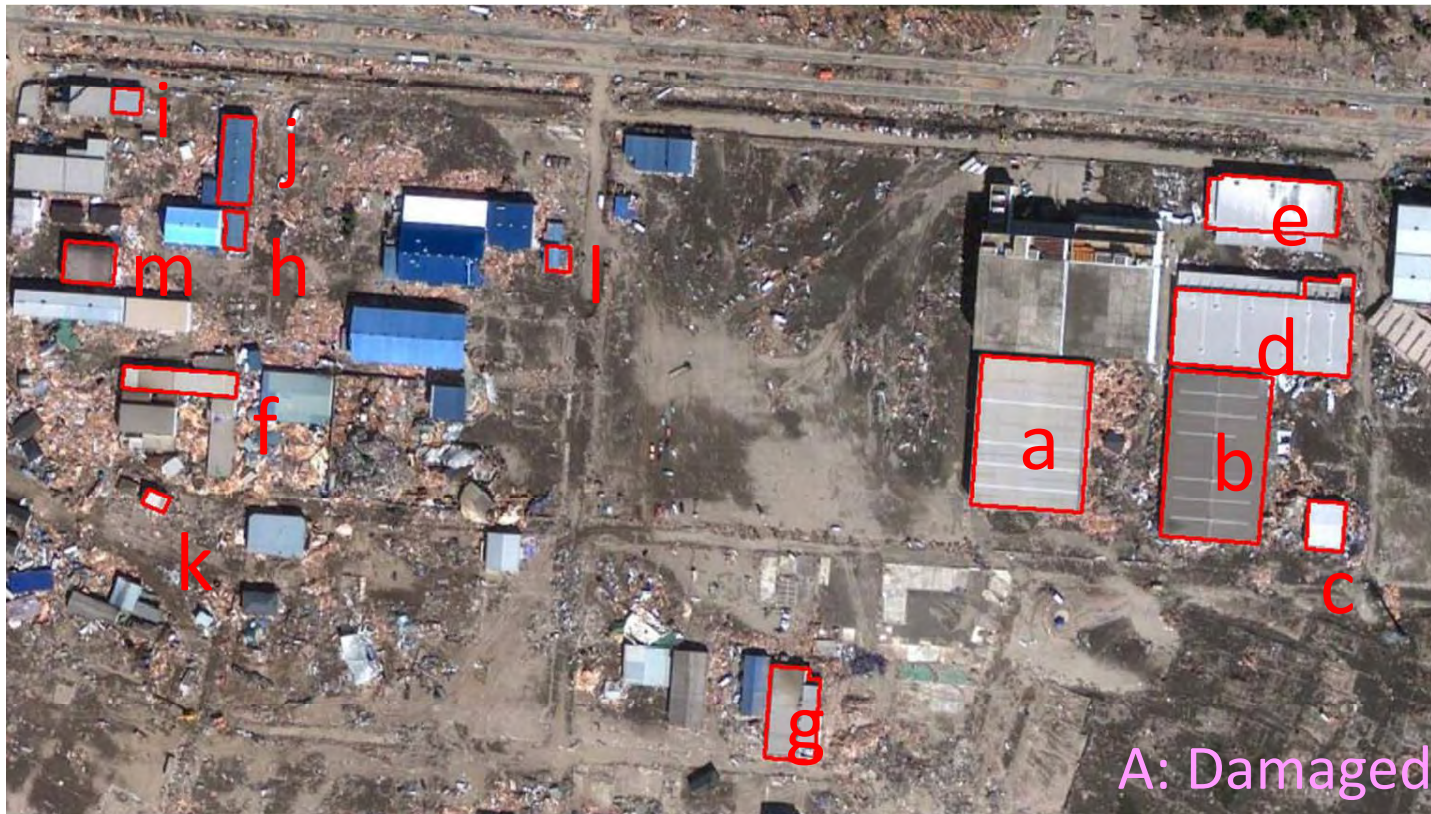
Aerial images of Sendai-Shiogama Port and its surroundings after the tsunami attack.

Area A within the tsunami inundation zone

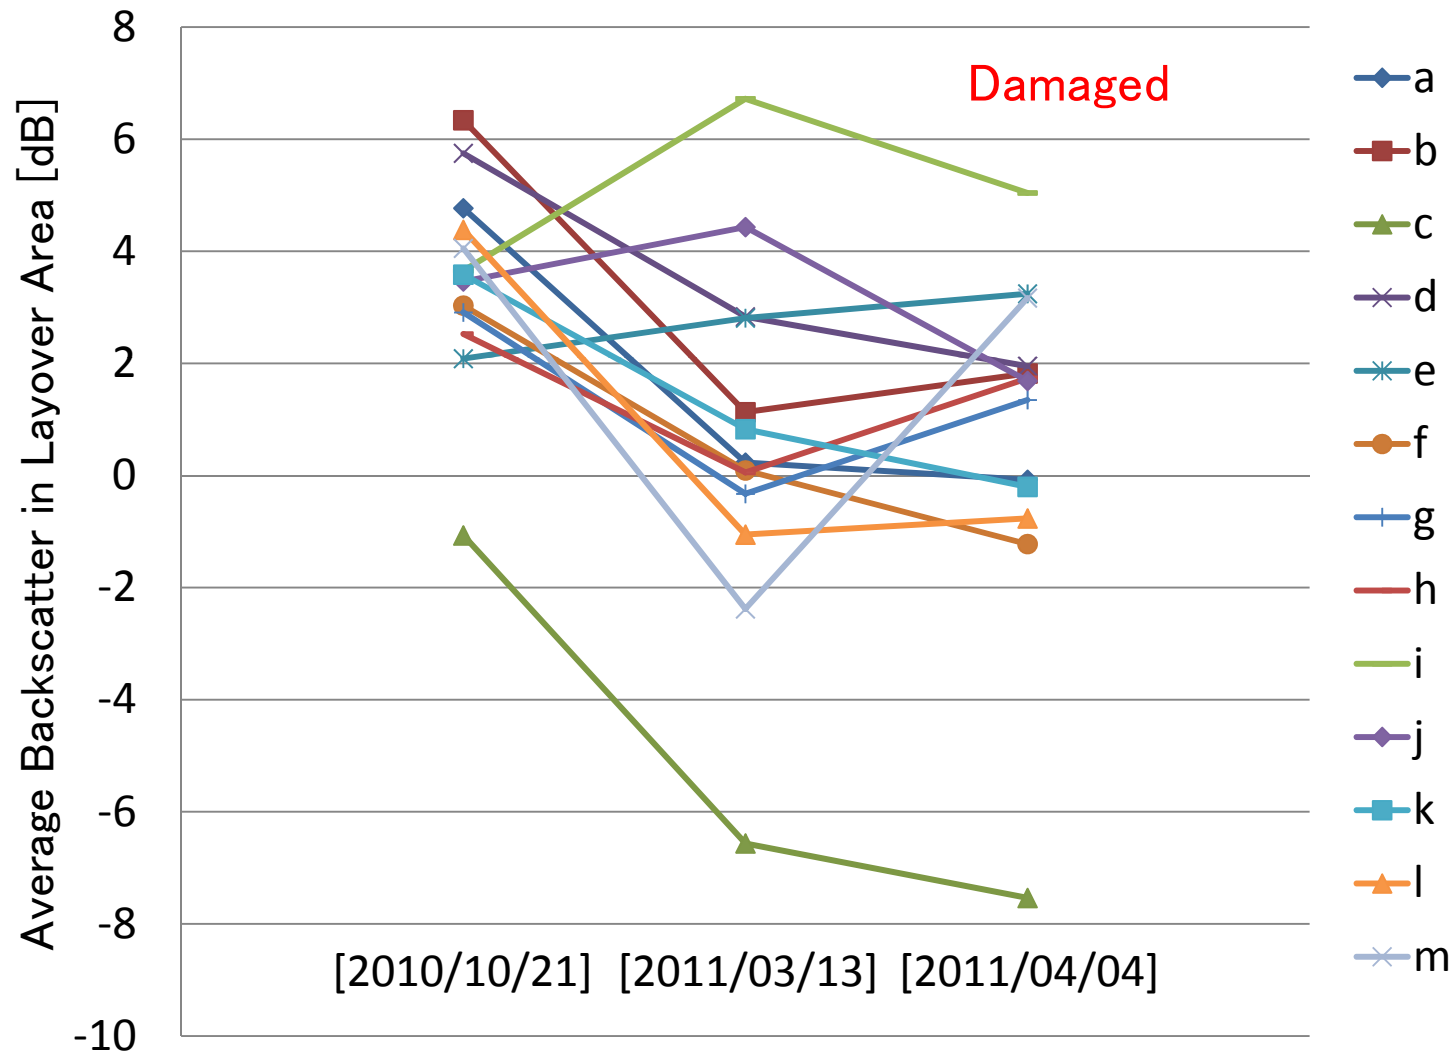
Average value of σ_0 within the layover area of each building for **13 damaged buildings** at 3 time instants of SAR image acquisition.

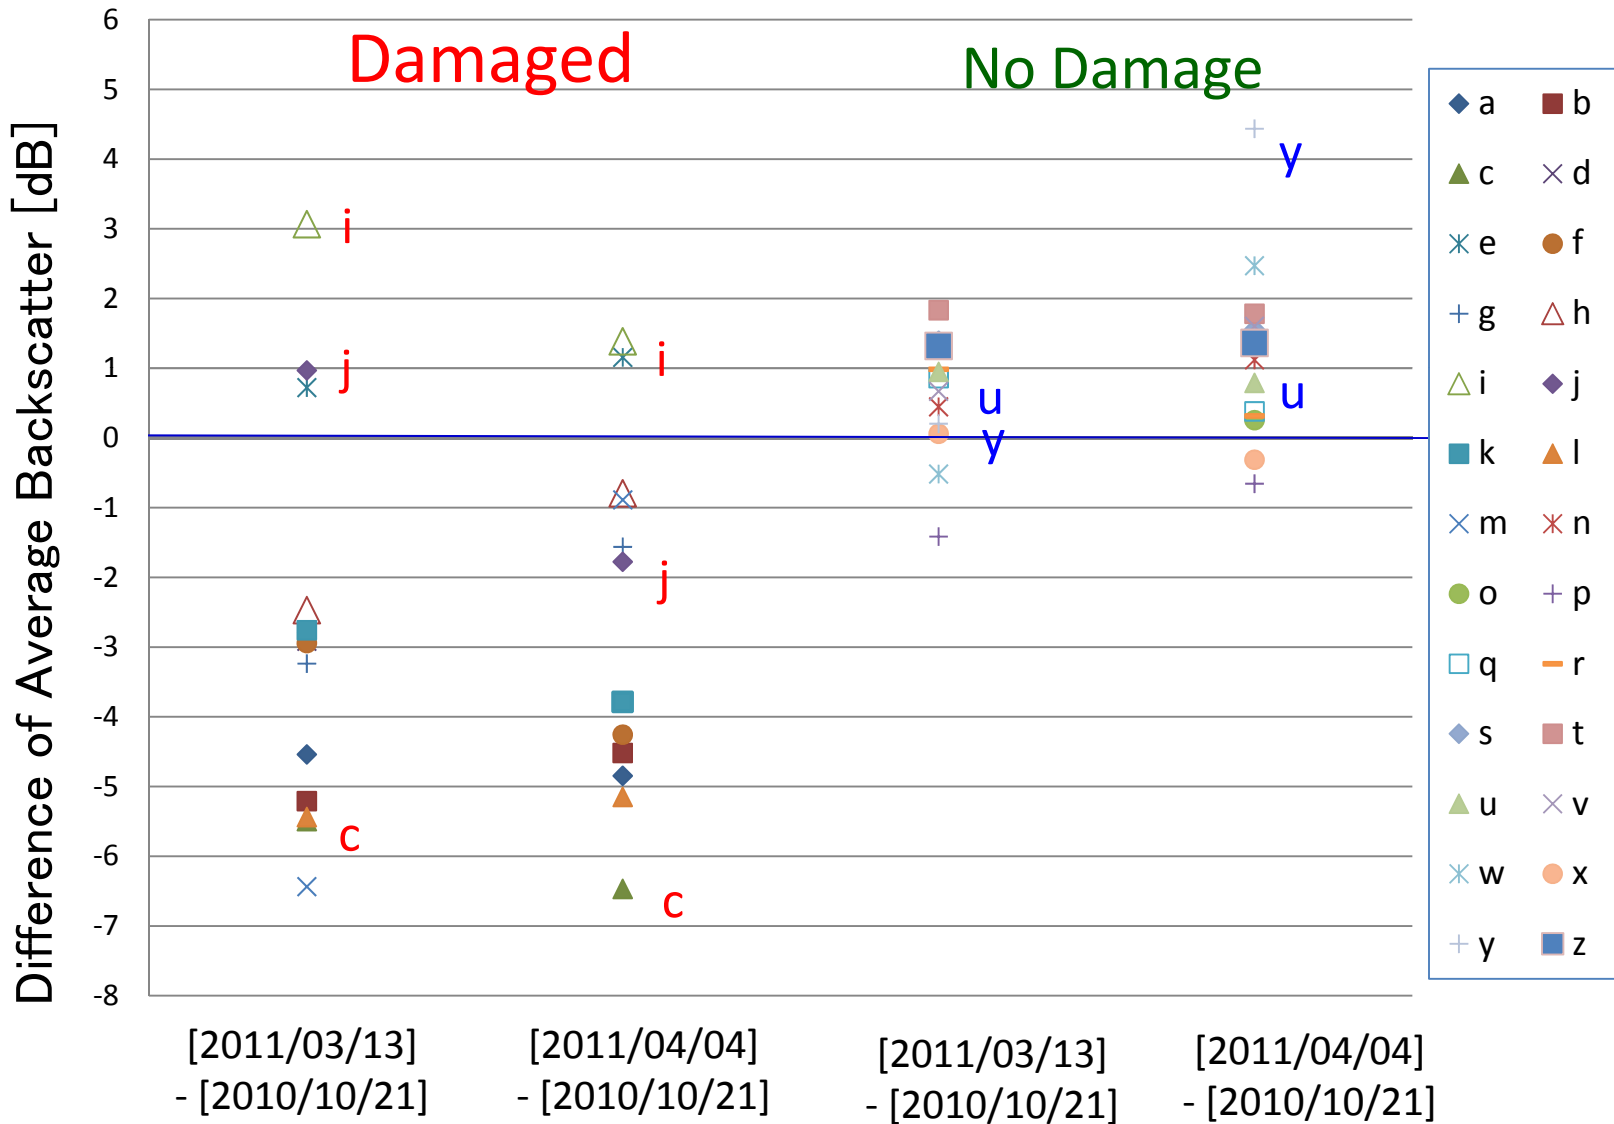
The difference of the average values of σ_0 within the layover area of each building before and after the tsunami attack

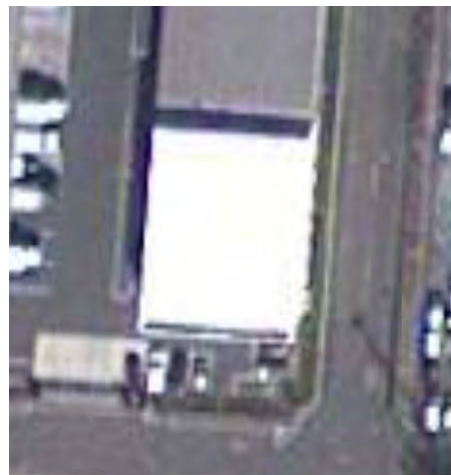
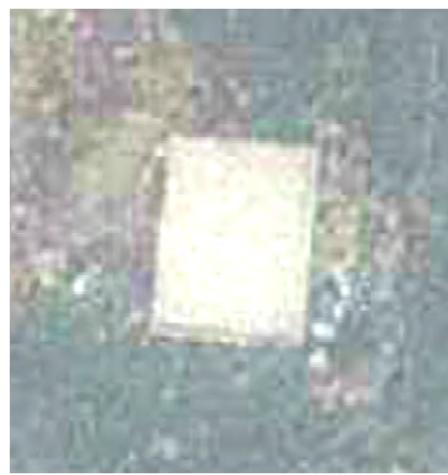
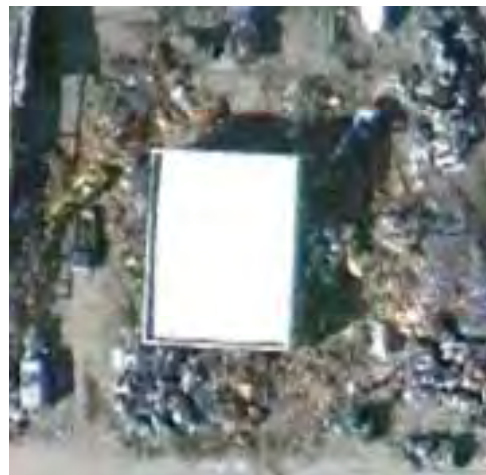
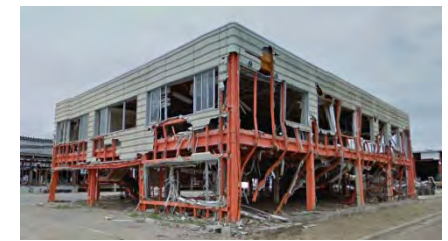
Close-up of the TSX images at the three acquisition dates and the optical images of similar acquisition times for **damaged building c**

Reduced σ_0

平均値	標準偏差	平均値の差 (事後—事前)	標準偏差の差 (事後—事前)
c	2010/10/21	-1.07	3.78		
	2011/03/13	-6.56	4.45	-5.49	0.69
	2011/04/04	-7.54	3.71	-6.47	-0.04

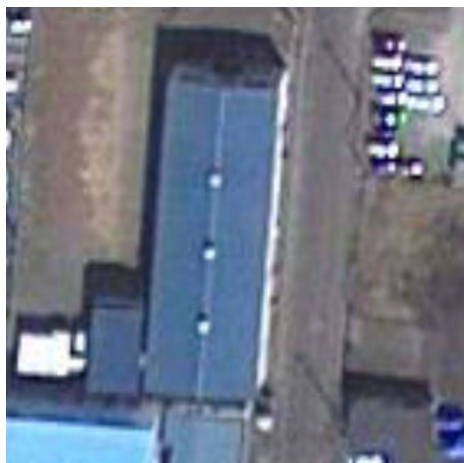
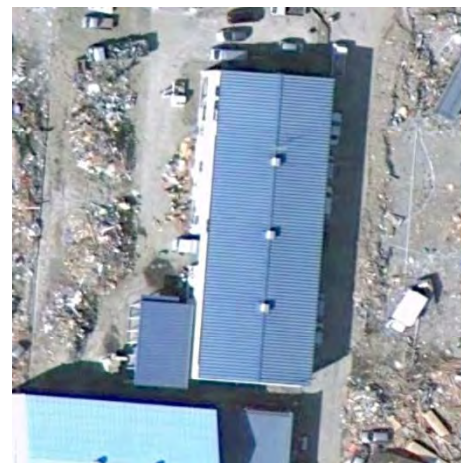
Close-up of the TSX images at the three acquisition dates and the optical images of similar acquisition times for **damaged building j**

Increased σ_0 on 3/13

Relatively small damage to exterior wall.

Spread of debris on 3/13 but cleared on 4/04.

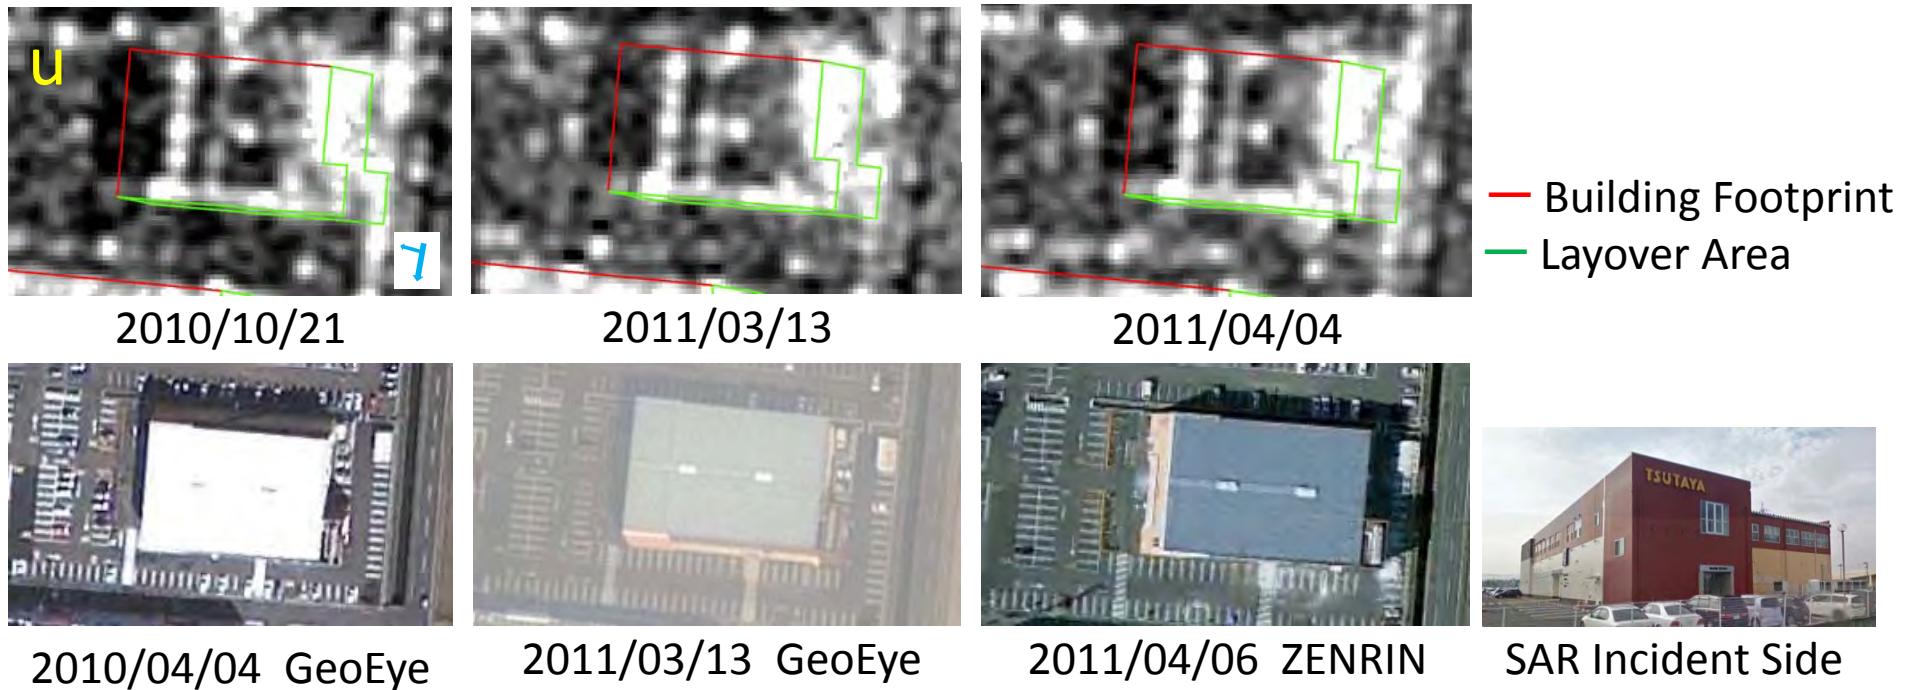
Close-up of the TSX images at the three acquisition dates and the optical images of similar acquisition times for **no damage building u**

No damage.

σ_0 was almost no change.

平均値	標準偏差	平均値の差 (事後—事前)	標準偏差の差 (事後—事前)
u	2010/10/21	2.43	8.25		
	2011/03/13	3.38	8.23	0.95	-0.02
	2011/04/04	3.22	8.17	0.79	-0.09

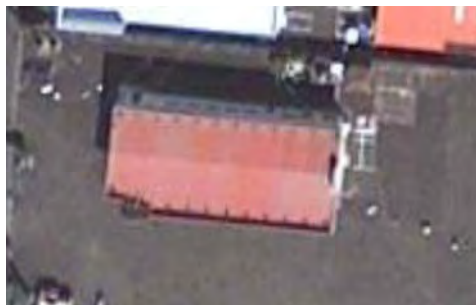
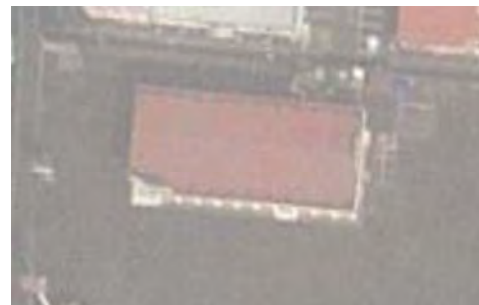
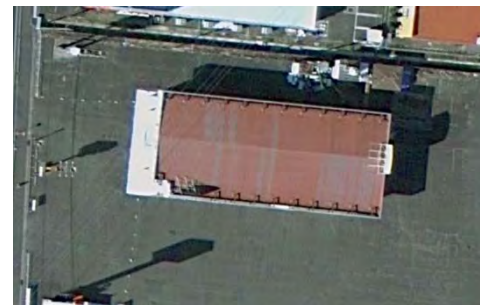
Close-up of the TSX images at the three acquisition dates and the optical images of similar acquisition times for **no damage building y**

No damage.

σ_0 increased on 4/04. Maybe due to parking cars?
