Sumatra Earthquake 26 Dec 2004

Teddy Boen

1. Aceh Tsunami Dec 26, 2004

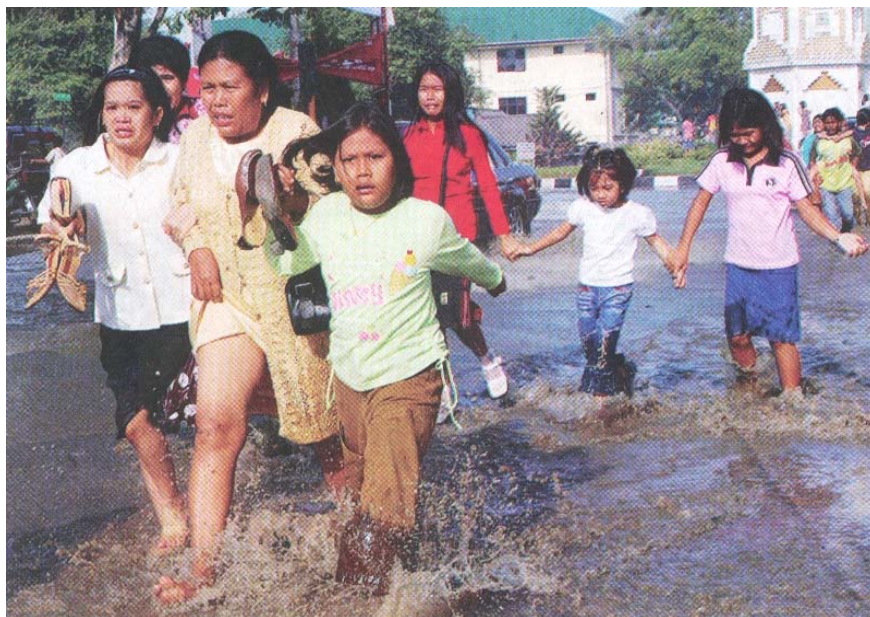
Source: Kompas, 15 January 2005

Banda Aceh: People were running to higher grounds after the first wave.

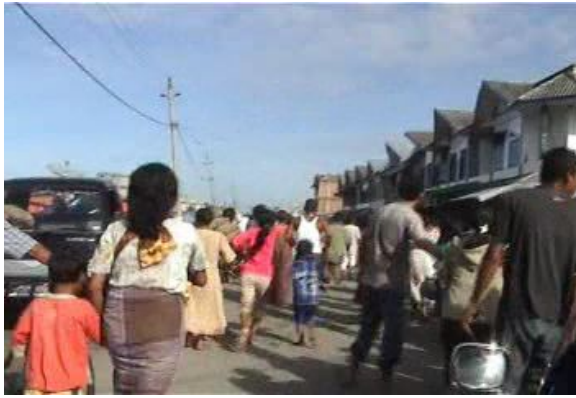
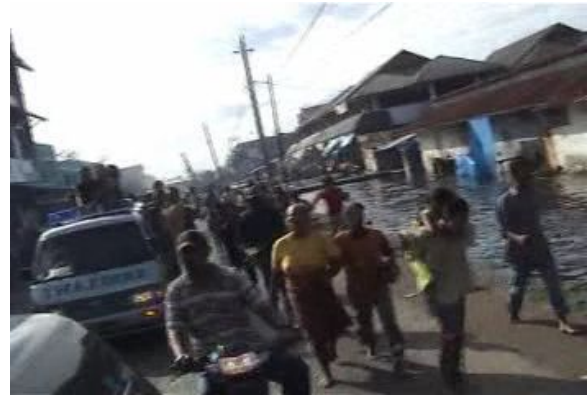
Source: Korem 012

Meulaboh: People were running to higher grounds after the first wave.

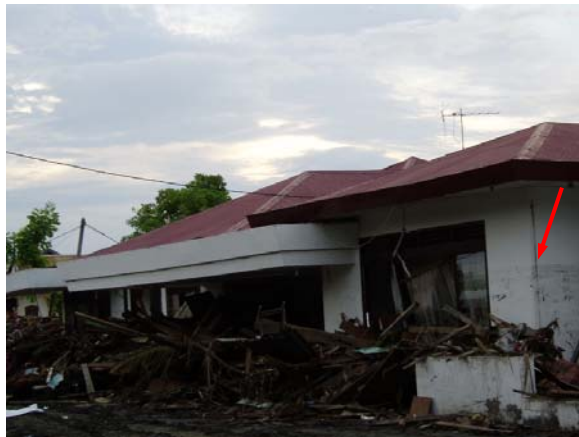
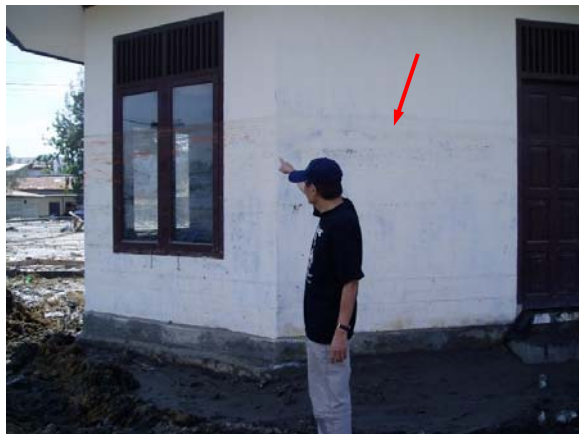
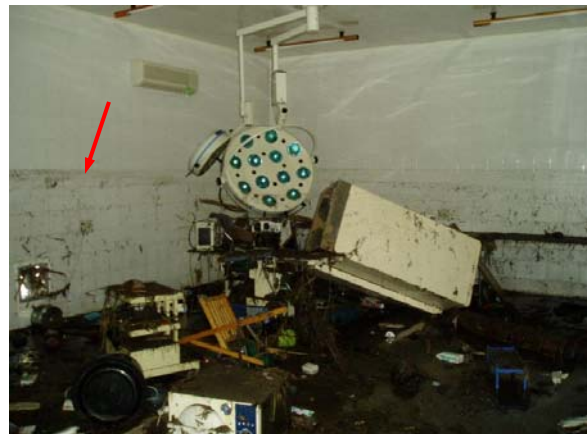
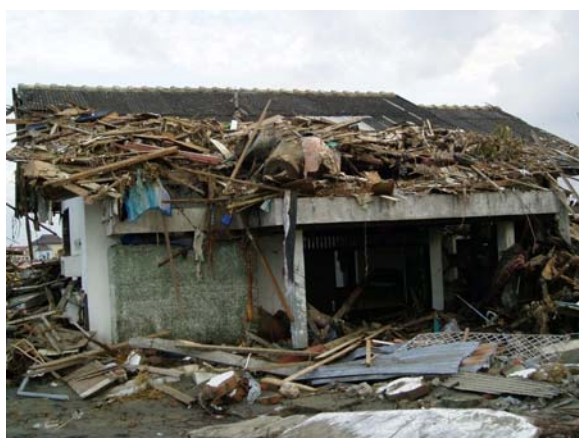
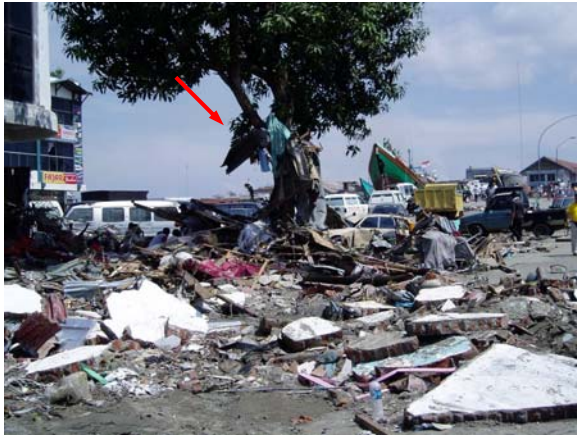
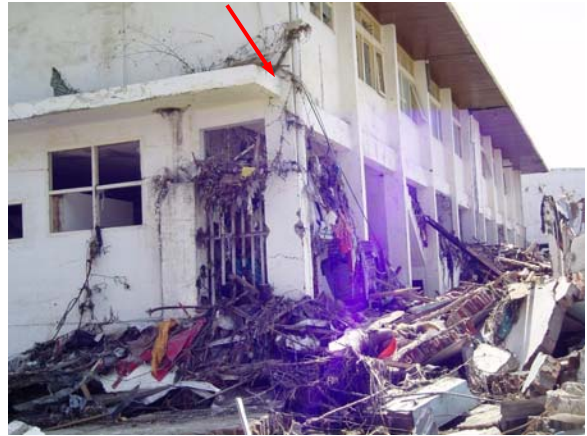
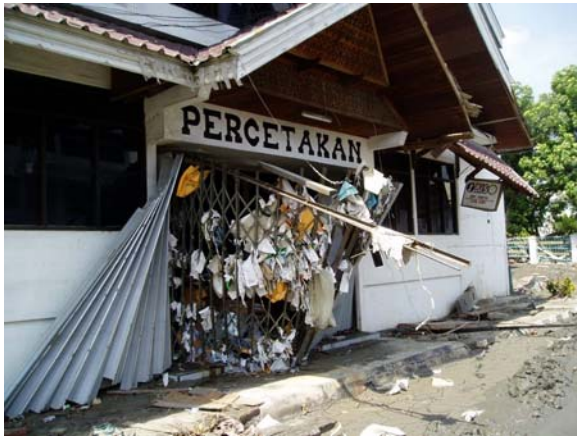
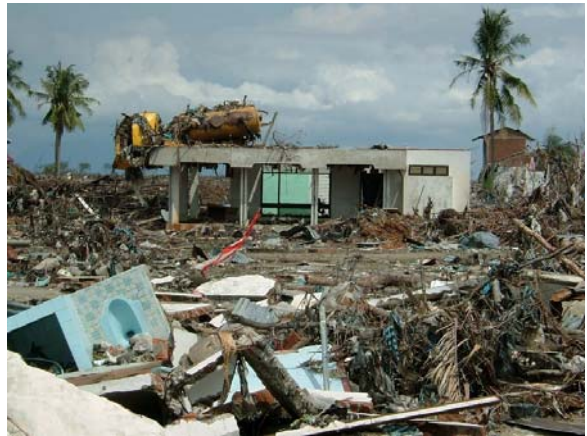
Inundation Height in Banda Aceh

The different tsunami heights in different locations have almost the same destructive powers as can be seen in the pictures.

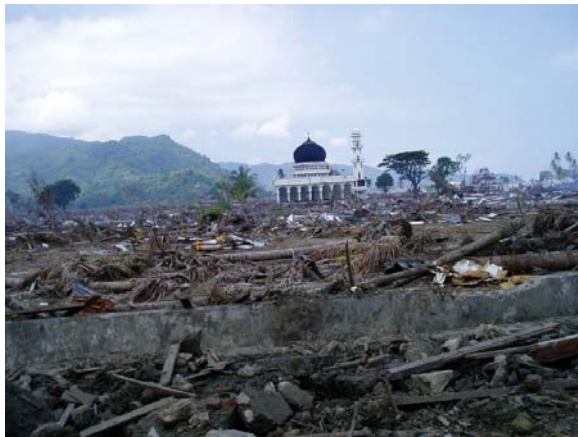
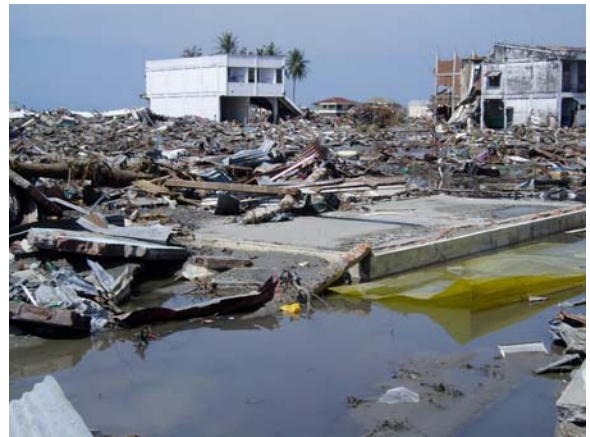
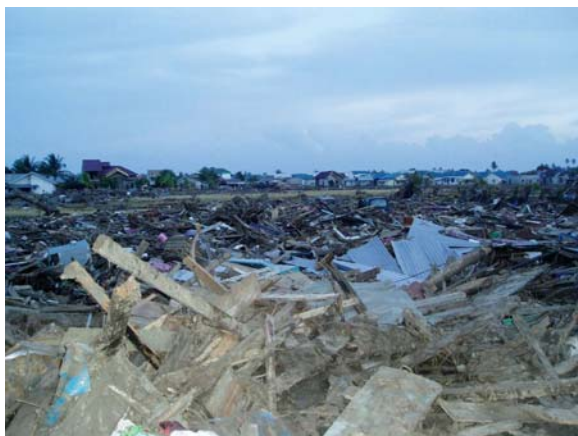
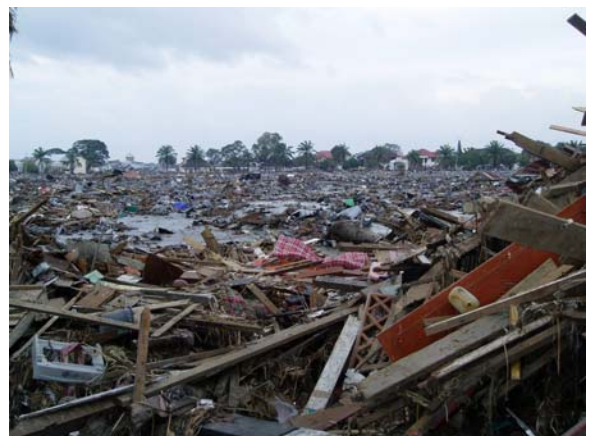
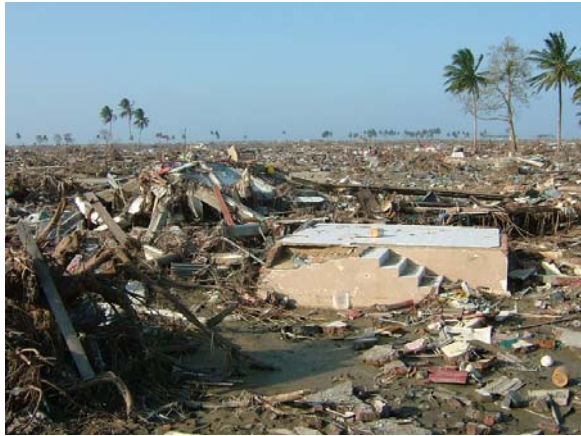
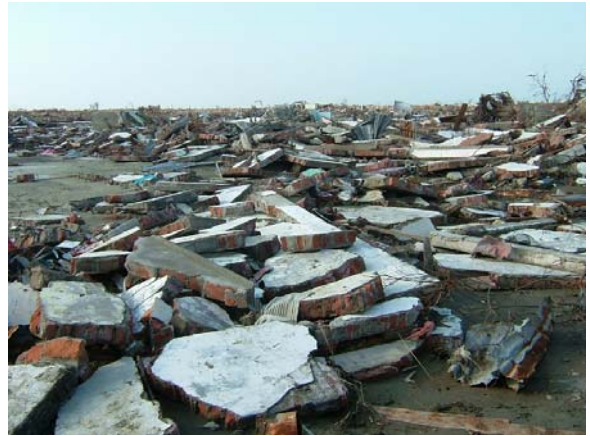
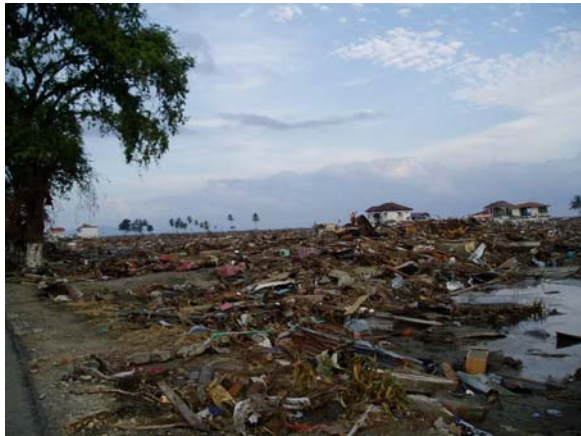
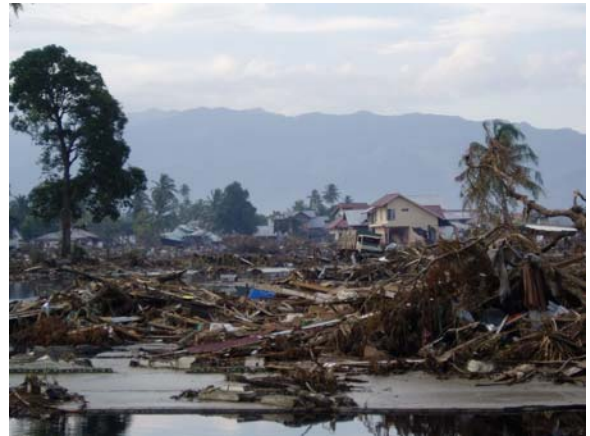
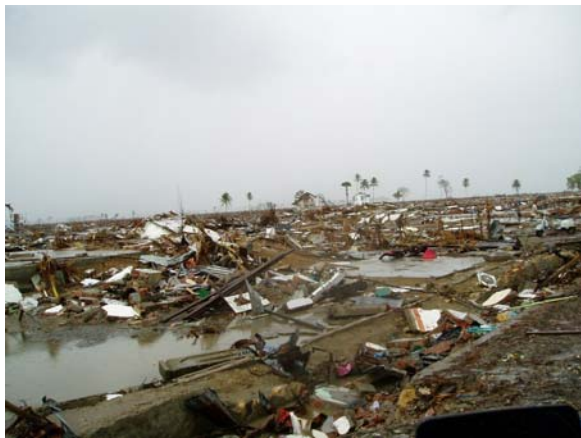
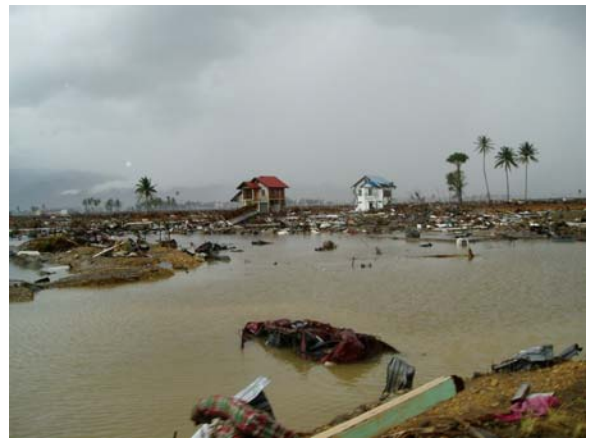
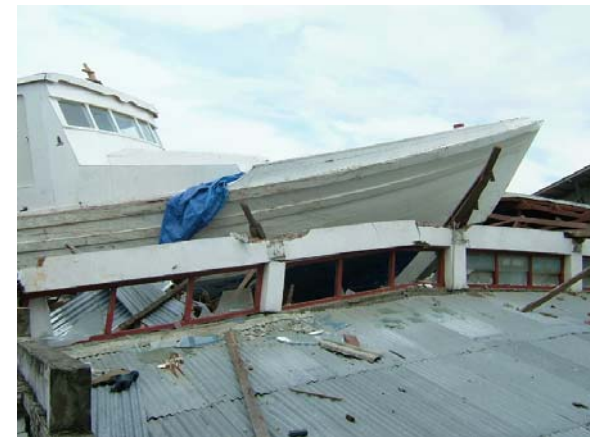
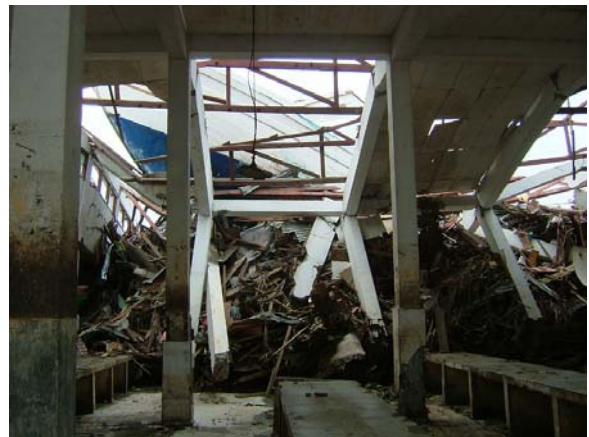
Banda Aceh (Zone 1)

Almost none of the people's housing, one to two story masonry buildings collapsed by the shaking, even though some had cracks in the walls. **The destruction was caused by the tsunami forces.**

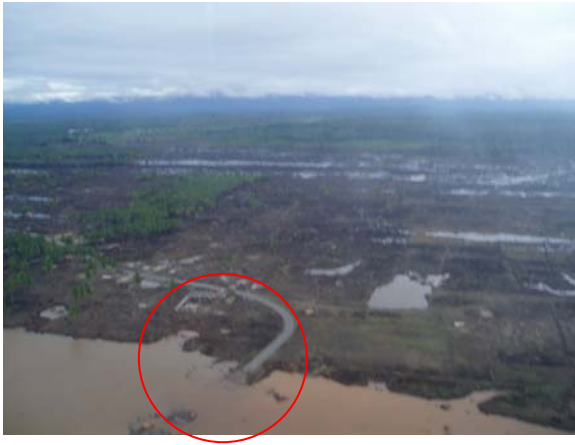
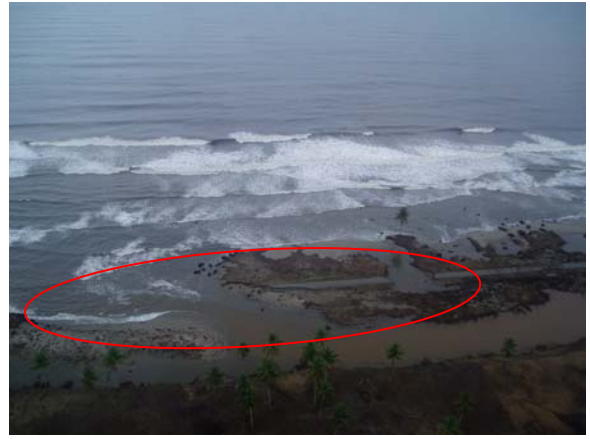
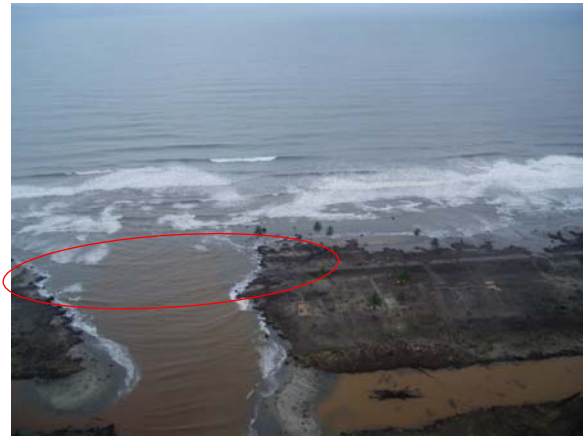
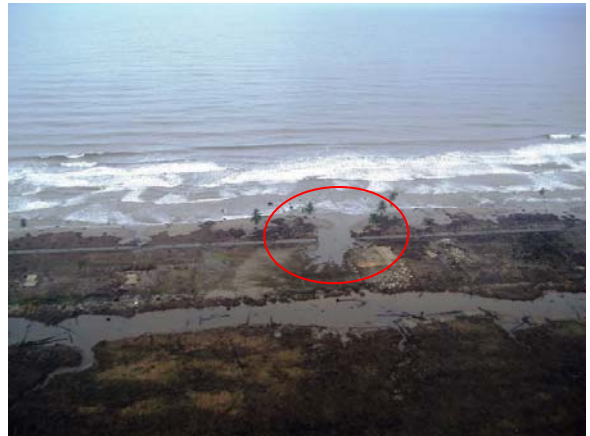
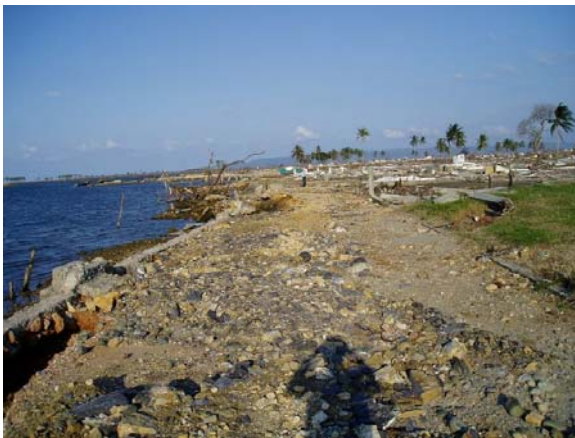
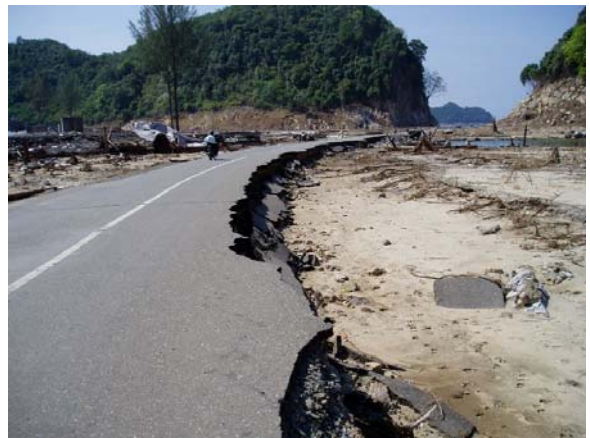
Some of the Damage of Roads and Bridges from Banda Aceh to Meulaboh

As was the case with buildings, most of the damage of infrastructures was caused by the strong force of tsunami and not by shaking.

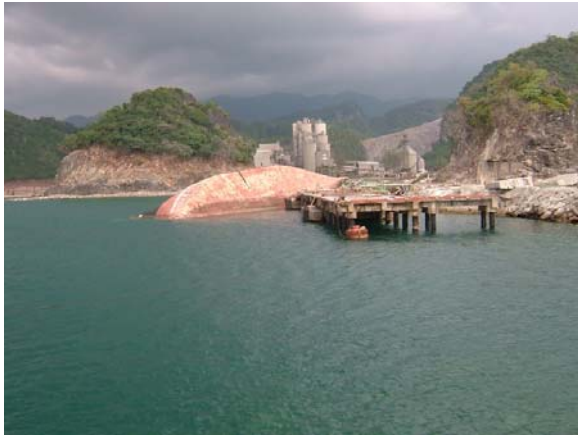
Lhok Nga Cement Factory Jetty

Generally, jetties and wharf of ports in Banda Aceh and in Kreung Raya as well as the jetty of the cement factory Lhok Nga were slightly damaged but could still function. Part of the platform of the jetty in Meulaboh was washed away by tsunami, but the supports were still in tact. The main building of the Ulhue Lhe harbor in Banda Aceh was damaged and only the frame remained.

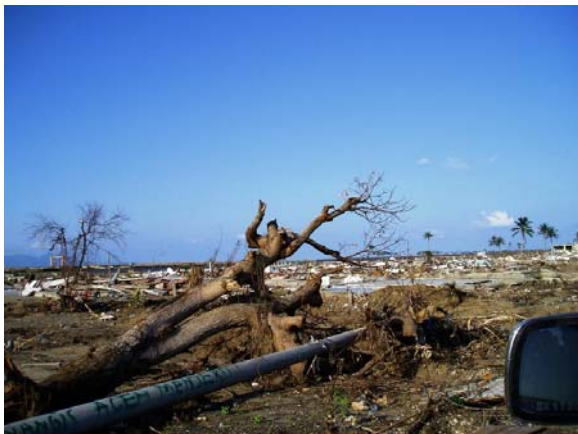
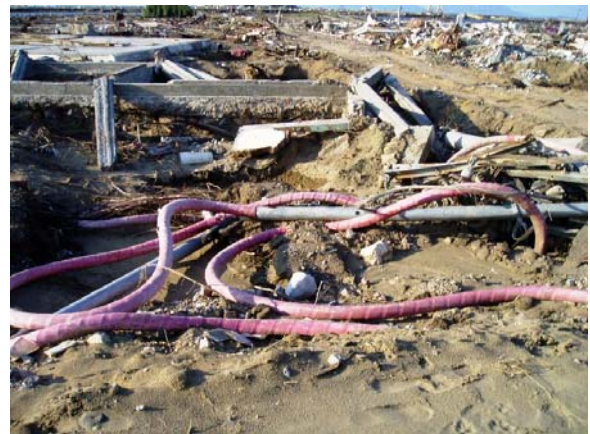
Main Power generating plant in Banda Aceh was not affected by the shaking or tsunami. However, many distribution poles and wires in devastated areas collapsed.

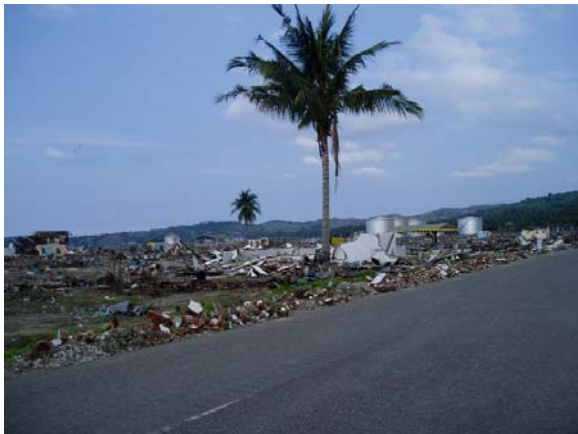
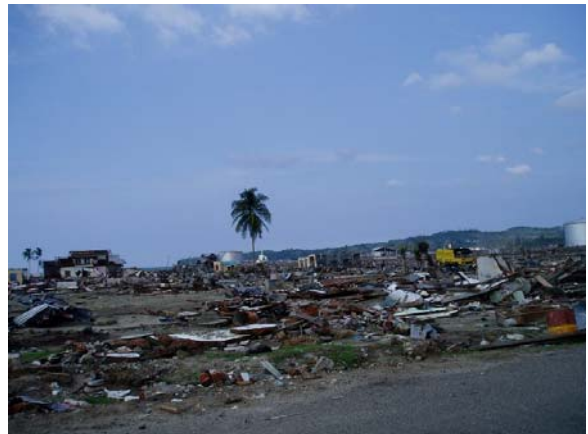
Pertamina Oil Depot, Krueng Raya

- A cement factory located at beach side in Lhok Nga district was severely damaged.
- Oil depot in Kreung Raya (East of Banda Aceh) was damaged and several storage tanks were dragged up to 1 km. The tanks were submerged by about one-third of its height.
