IWMI and DMC in close association with Sentinel Asia System (SAS) and JAXA activated the charter on October 1, 2015 to provide satellite images covering the Southern Provinces. SAS quickly provided images of 30 September 2015 and 1st October 2015 for its use in emergency response and relief operation. IWMI using the IFMAN tool processed the flood extent covering the districts of Hambantota, Galle, Matara, Monaragala and Ratnapura.

Flood Extent (01 Oct 2015)

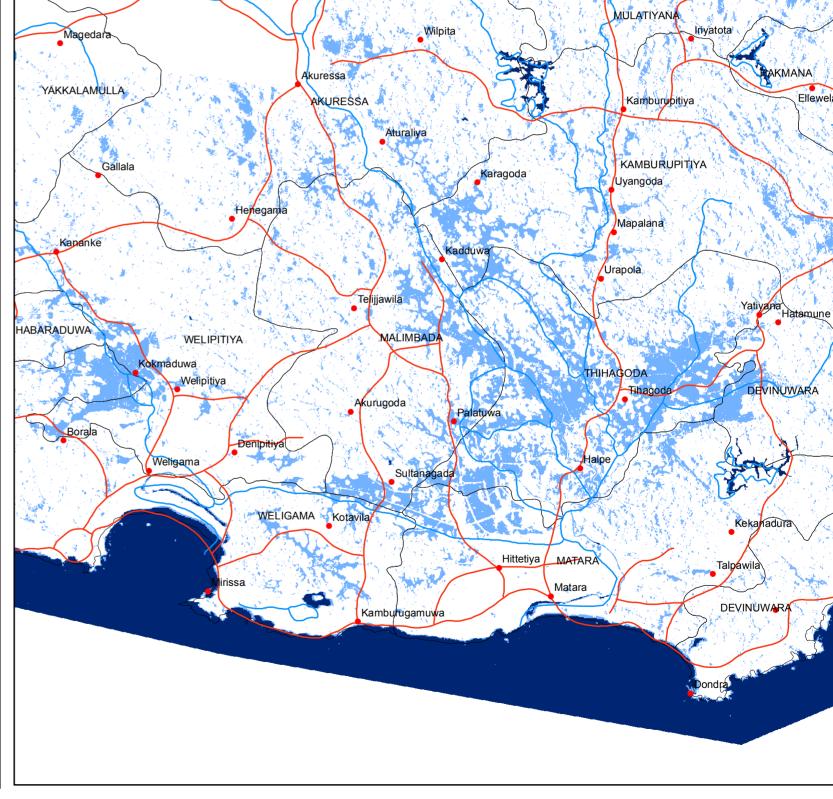
In total an area of 365 sq.km were inundated as viewed by ALOS PALSAR Satellite images taken on 30 September 2015. Approximately 150sq.km of paddy fields were flooded. The data sources from Survey Department of Sri Lanka was used for this analysis purpose. Major flooded affected divisions are Hambantota, Tanamalwila, Lunugamwehara, Tissamaharama, Wellawaya and Embilipitiya. In terms of major paddy field affected division's area Hambantota, Tanamalwila, Tissamaharama, Lunugamwehara and Tangalla. For the ALOS PALSAR-2 images taken on 1st October 2015, the affected districts are mainly the Matara and Galle. The divisions that includes Thihagoda, Kamburupitiya, Malimbada, Akuressa, Mulatiyana. In total 15 divisions were affected with a maximum inundation of 89sq.km of which paddy fields affected area is 47sq.km. The division with paddy field affected areas are Thihagoda, Malimbada, Kamburupitiya.

Before Disaster Image: ALOS PALSAR 2
Date :18 Feb. 2015
After Disaster Image : ALOS PALSAR 2
Date :01 October.2015
